# Investigation of Mould Growth

Carol Scout Lodge

Baden Powell Road, Labrador City, Newfoundland and Labrador

January 11, 2018

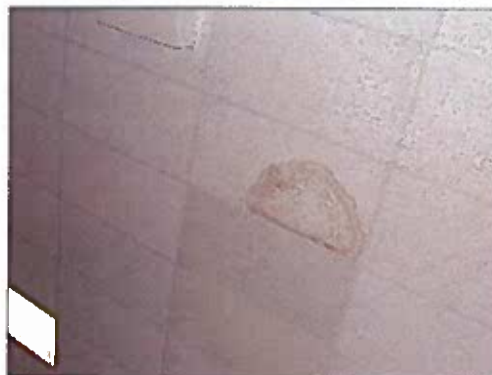
**Photo 2 – View of water-stained ceiling tile in the Gymnasium, approximately 16 feet from the west wall.**

Water-stained ceiling tiles (4 ft<sup>2</sup>) were observed in the gymnasium approximately 16 feet from the west wall (Photo 2).

7. Investigate the crawlspace for a decaying animal.
8. Replace all water-stained ceiling tiles in the Gymnasium and the Kitchen.
9. Clean the water-stained door and sink in the Classroom.

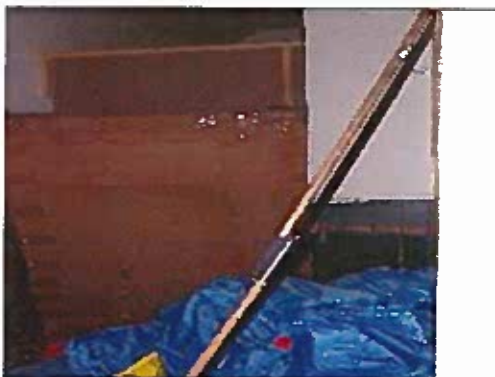
**Photo 3 – View of damp cardboard and other debris observed in Storage Room #1.**

In Storage Room #1, an unpleasant odour was noted and elevated moisture readings were detected on the north wall. Damp cardboard and other debris were observed on the floor of Storage Room #1 (Photo 3). Storage Room #2 was inaccessible at the time of the investigation. In Storage Room #3, water-damaged drywall was observed on the south wall in the form of delaminating paint (2 ft<sup>2</sup>) and cracks were observed on the ceiling above the damaged wall (Photo 4). Elevated moisture readings were also detected on the south wall.

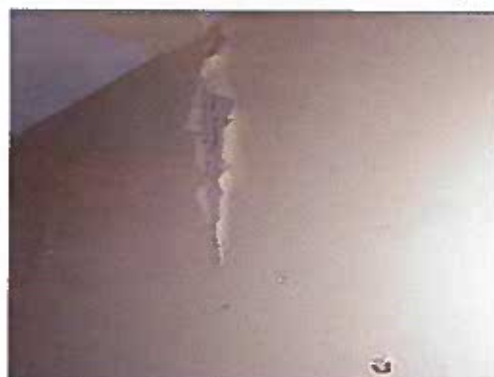
**Photo 4 – View of peeling paint on the south wall of Storage Room #3.**

- b. Remove the top 3' x 2' section of drywall on the south wall near the wall/ceiling interface and remove a 2' x 2' section of damaged ceiling above the damaged south wall in Storage Room #3 in the Gymnasium.

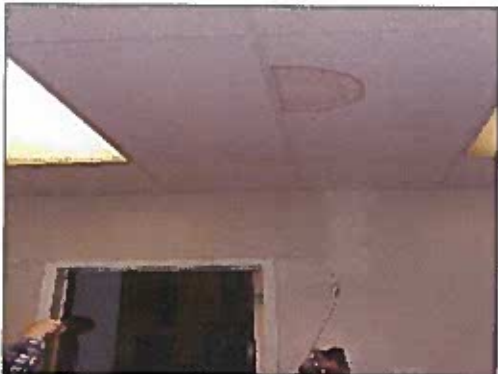
Photo 9 – View of water-stained ceiling tile and re-plastered wall in the Kitchen.	Photo 10 – View of water-stained ceiling tile in the middle of the Kitchen.

The Kitchen dimensions are approximately 30 by 22 feet. Several water-stained ceiling tiles were observed (Photos 9 and 10). Water stains were also observed on some of the floor tiles. A section of drywall above the doorway leading out to the Gymnasium was cracked and has been re-plastered (4 ft<sup>2</sup>; Photo 9).

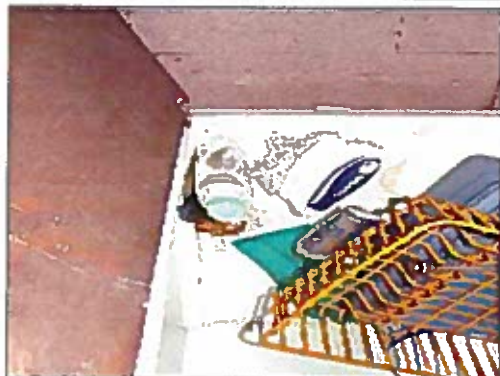
Photo 11 – View of mould growth underneath the sink along the west wall, inside a cabinet.

Mould growth was observed on the floor of the panel board cabinet below the sink located along the west wall (Photo 11). In addition, mould growth was also observed on the surface of the oven storage door (Photo 12).

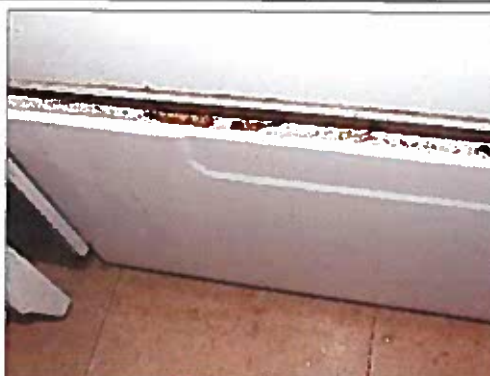
Photo 12 – View of mould growth on the oven in the Kitchen.

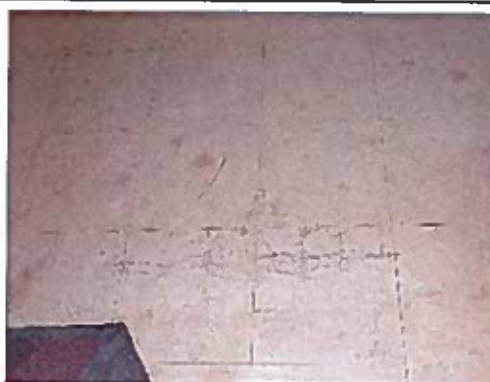
Photo 14 – View of cracked and water-stained floor tiles near the front entrance in the Lobby.

The Lobby is L-shaped; the dimensions are approximately 6 by 28 feet in the front section by the entrance and 8 by 16 feet in the back section towards the hallway. The walls are composed of drywall with wood panel overlay on the bottom portion extending up 5 feet from the floor. There were several cracks in the drywall walls which had been re-plastered, approximately 4 ft<sup>2</sup> total. The floor tile was cracked and water-stained and was in poor condition near the front entrance (Photo 14). In addition, there were water stains at the base of the wall above the damaged floor tiles near the front entrance, approximately 6 ft<sup>2</sup> in total.

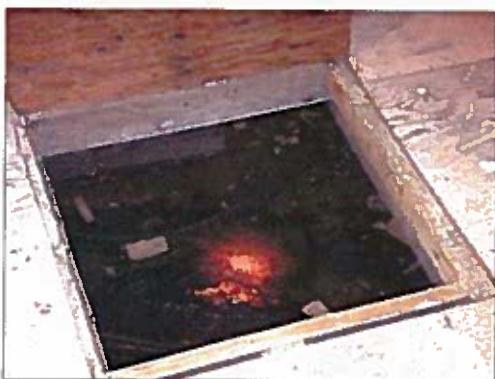
Photo 15 – View of access to the crawlspace with a pool of standing water and abundant debris below the access hatch.

A 2 ft<sup>2</sup> pool of standing water was observed on the crawlspace floor directly below the hatch (Photo 15). The crawlspace was not investigated as there was no ladder available to reach the floor.

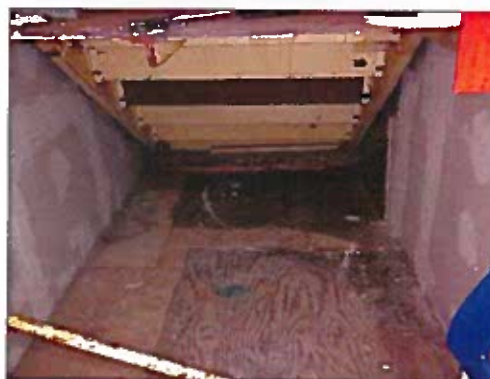
Photo 16 – Sticky residue and suspect mould growth to the right of the crawlspace access hatch, underneath the stairwell.

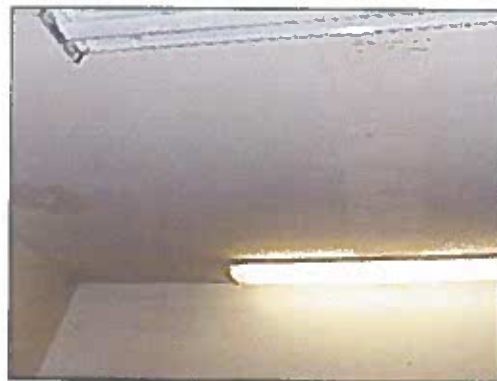
Photo 20 – Cracked drywall ceiling that was re-plastered in the Classroom.

The Classroom dimensions are approximately 30 by 22 feet. There were several spots where the drywall ceiling had cracked and was re-plastered, approximately 15 ft<sup>2</sup> in total (Photo 20). Approximately 4 ft<sup>2</sup> of peeling paint was observed above the baseboard heater on the south wall (Photo 21). Mould growth was observed on the surface of the drywall wall in the northeast corner, approximately 10 feet away from the doorway leading to the Lobby (Photo 22). Minor water stains were noted on the floor tiles in several spots (2 ft<sup>2</sup>). There is a sink in the southwest corner across from the Electrical Room doorway and water stains were observed surrounding the sink basin and running down the side of the sink. In addition, mould growth was observed on the bar of soap next to the tap (Photo 23).

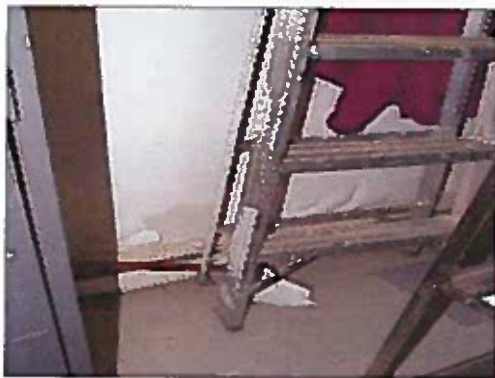
Photo 21 – View of peeling paint on the south wall of the Classroom, just above the baseboard heater.

- h. Remove the water-damaged drywall on the south wall above the baseboard heater, on the east wall just above the baseboard, and above the sink on the west wall in the Classroom.

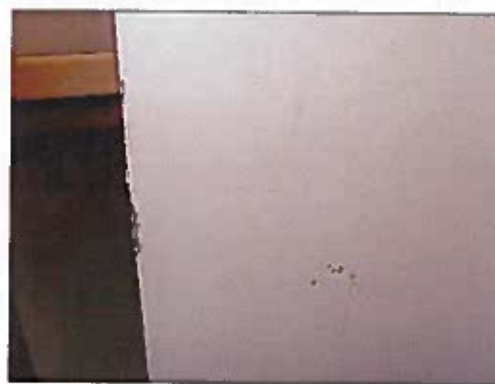
Photo 22 – View of mould growth on the surface of the drywall wall in the northeast corner of the Classroom.

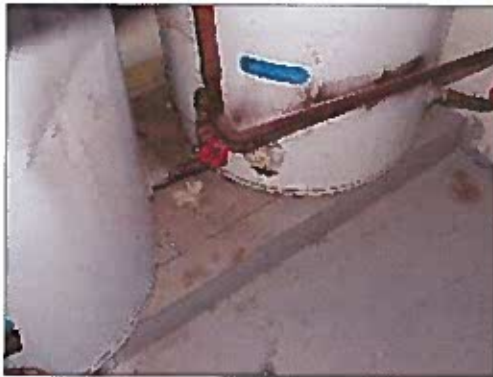
Photo 25 – View of base of hot water tanks with some water staining on the floor in the Small Storage Area leading into the Electrical Room.

In the southeast corner of the Classroom there is a doorway leading into a Small Storage Area which then further leads to an Electrical Room, with dimensions of approximately 11 by 9 feet (Photo 24). There are two hot water tanks in the Small Storage Area along the south wall. Exposed insulation was noted around the base of the tanks and minor water stains was noted on the floor (Photo 25). Inside the Electrical Room there is evidence of water damage; this includes staining on the door leading into the Electrical Room (2 ft<sup>2</sup>). There is staining behind the electrical wood panelling all along the east and south walls (10 ft<sup>2</sup>). There is damp insulation around the base of the creosote treated log in the northeast corner and mould growth on the wood joists behind the log along the north wall (2 ft<sup>2</sup>; Photo 26).

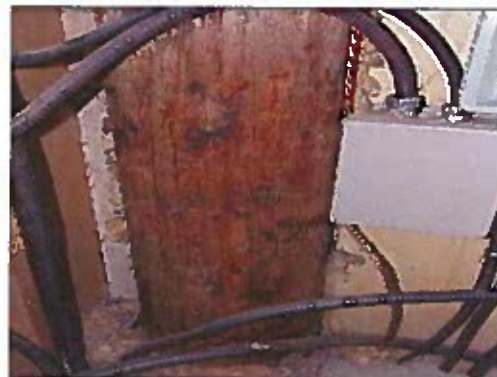
Photo 26 – View of water stains behind electrical panelling inside the Electrical Room. Damp insulation around the base of the creosote treated log. Mould growth on the wood joists.

- g. Abrasively clean with an appropriate mould disinfectant the water-damaged wood panels along the east and south walls in the Electrical Room.

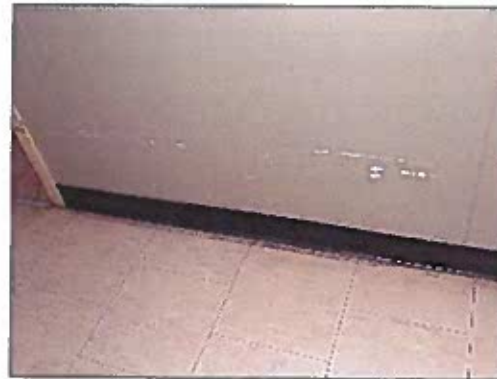
Photo 28 – View of minor water staining at the base of the east wall in the Hallway.

The hallway dimensions are approximately 8 by 32 feet. The walls are composed of drywall with wood panel overlay on the bottom portion extending up 5 feet from the floor. Minor water stains were noted at the base of the walls in several spots (Photo 28).

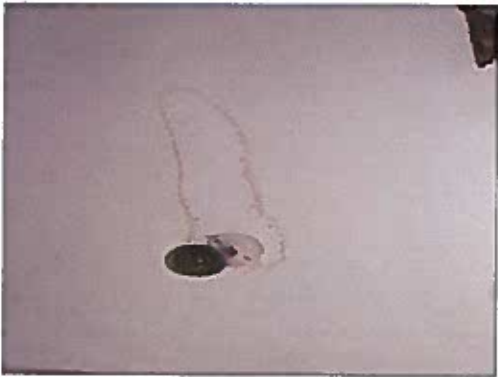
Photo 31 – View of water staining around light bulb on the ceiling in the Janitor's Closet.	Photo 32 – View of water-stained and damaged drywall accompanied by mould growth on the bottom of the west wall adjacent to the doorway in the Janitor's Closet.

The Janitor's Closet dimensions are approximately 5 by 9 feet. Water-stained drywall was observed surrounding the light fixture on the ceiling (2 ft<sup>2</sup>; Photo 31). Water-stained drywall was also observed on the west wall adjacent to the doorway (Photo 32). Water staining was also observed throughout the plywood floor (4 ft<sup>2</sup>; Photo 33). An active water drip was noted from the tap of the sink located on the

- i. Remove the water-damaged drywall on the ceiling around the light fixture in the Janitor's Room.
  - j. Remove the water-damaged drywall on the bottom of the west wall in the Janitor's Room.

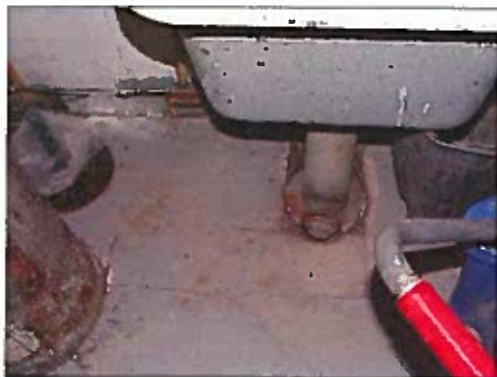
Photo 33 – View of water staining on the floor and around baseboards in the Janitor's Closet.

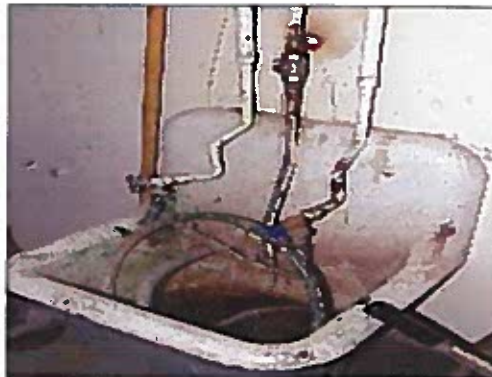
Photo 34 – View of active water running from the tap of the sink.

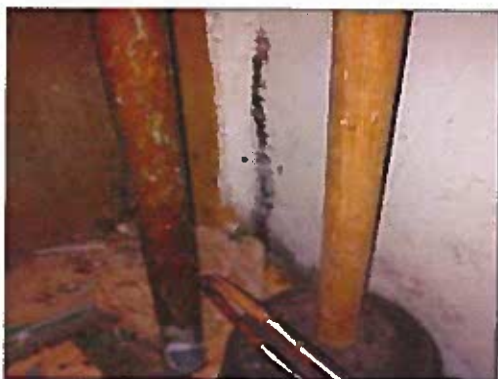
Photo 35 – View of mould growth on drywall on the wall behind the creosote treated log in the northeast corner.

No moisture readings were obtained. Visible mould was observed on the drywall behind the creosote treated log in the northeast corner (1 ft<sup>2</sup>; Photo 35).

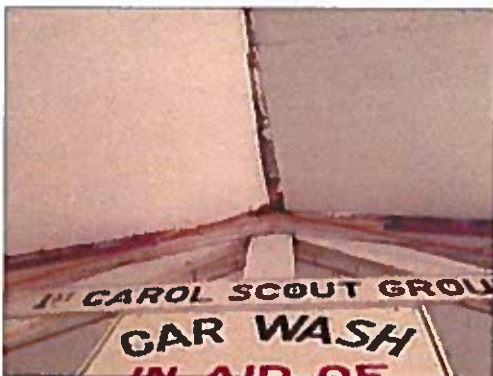
Photo 38 – View of damaged plywood ceiling of upstairs equipment room.

The Upstairs Equipment Room dimensions are approximately 29 by 30 feet. The ceiling is composed of plywood which was in poor condition in several areas (Photo 38). The walls are composed of plywood, and were blocked by lots of debris making access to them difficult (Photo 36). The floor is

- l. Repair the damaged plywood ceiling in the Upstairs Equipment Room.
  - m. Remove the water-damaged insulation in the north wall cavity in the Girl's Washroom.

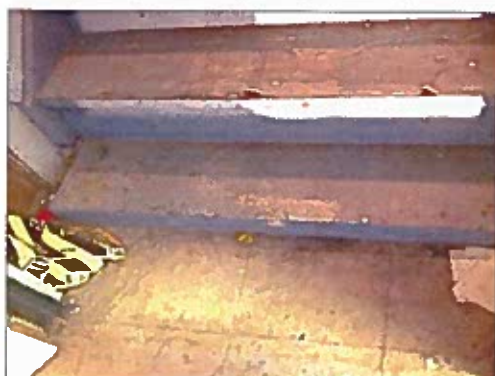
Photo 39 – View of bottom of stairwell leading to upstairs equipment room.

composed of plywood which was in good condition. The stairwell leading up to the Equipment Room is in poor condition, with peeling and cracked paint on the steps, and water stains on the wood joists at the bottom of the stairwell, approximately 4 ft<sup>2</sup> in total (Photo 39).

- k. Abrasively clean with an appropriate mould disinfectant the water-damaged wood joists at the bottom of the stairwell leading upstairs and the entire wood stairs.

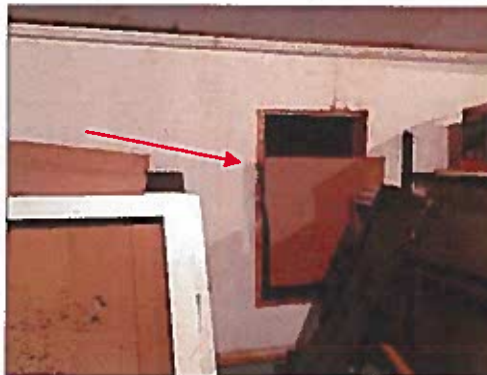
Photo 41 – View of access panel on north wall of upstairs equipment room leading into attic area above the Kitchen.

On the west wall of the Upstairs Equipment Room is a raised doorway leading out to the Attic that is located above the Gymnasium. The floor in the Attic is the backside of the pin-hole fissure ceiling tile in the Gymnasium and is covered in insulation in poor condition (i.e. damp) and other debris (Photo 40). On the north wall of the Upstairs Equipment Room is a small hole that gives restricted access to the Attic area that is above the Kitchen. The floor there is also the backside of the pin-hole flex ceiling tile in the Kitchen and is covered in insulation in poor condition (i.e. damp; Photo 41). The entire upstairs was noted to be very cold.

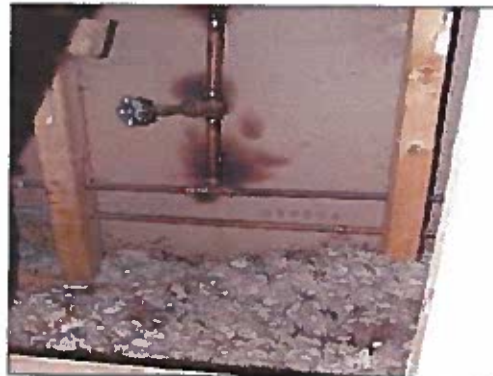
Photo 43 – View inside the wall cavity through the access panel in the Girl's Washroom, damp insulation was noted on the floor.

The Girl's Washroom dimensions are approximately 6 by 15 feet. Elevated moisture readings were not measured. However, in the wall cavity behind the access panel on the north wall to the left of the stalls there is damp insulation on the floor (4 ft<sup>2</sup>; Photo 43). Also behind that access panel, visible mould growth was observed on the drywall directly across from the opening; this wall is common with the Gymnasium (2 ft<sup>2</sup>; Photo 44). In the last stall on the northeast corner, there is a fungus growing at the base of the wall (Photo 45).

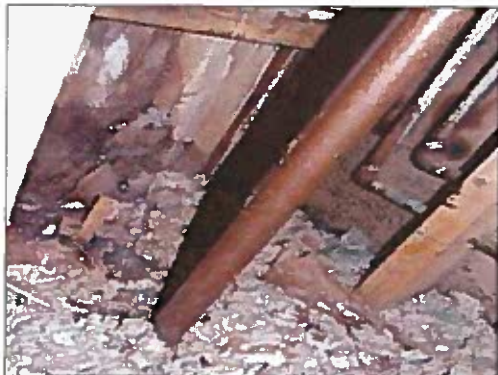
Photo 44 – View of mould growth on drywall facing north wall, behind access panel in Girl's Washroom.

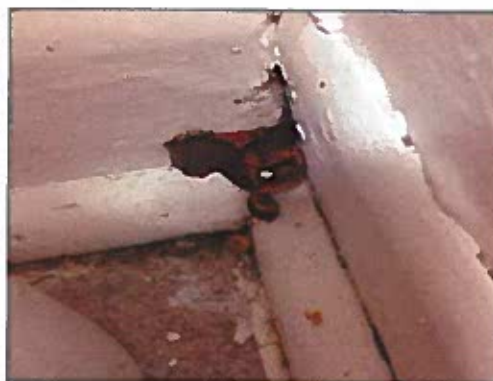
Photo 45 – View of fungus at base of wall in the northeast corner, last stall in Girl's Washroom.

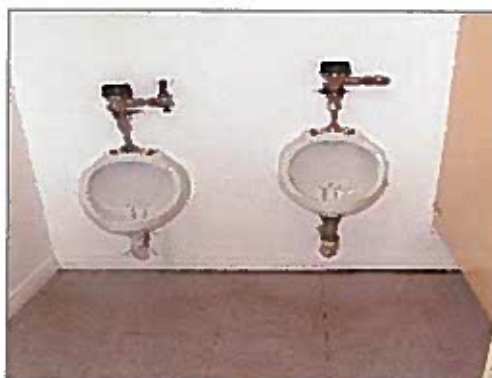
Photo 47 – View of urinals on the north wall of the Boy's Washroom, peeling paint on the piping at the bottom.

The Boy's Washroom dimensions are approximately 6 by 15 feet. Elevated moisture readings were not measured. Some peeling paint was observed on the piping at the bottom of the two urinals (Photo 47). Signs of visible mould growth were not observed.
