# Investigation of Mould Growth

Carol Scout Lodge

Baden Powell Road, Labrador City, Newfoundland and Labrador

January 11, 2018

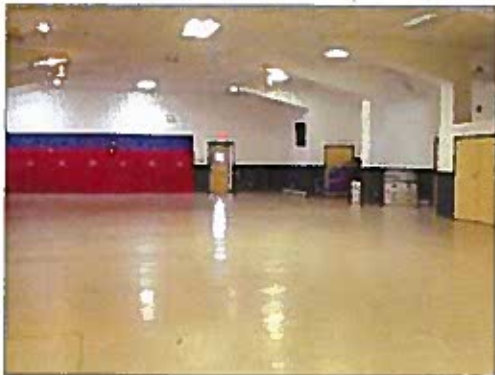
**Photo 1 – General view of the Gymnasium, facing the west wall. Doorways to Storage Rooms #1 and #2 are visible on the right.**

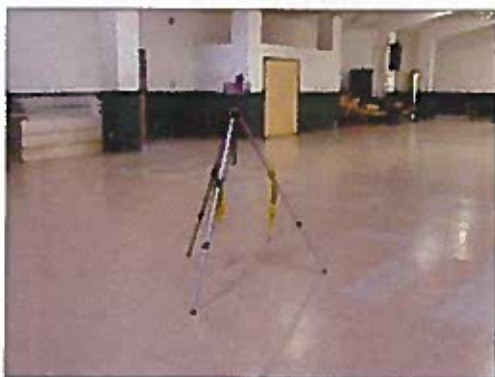
**Photo 5 – View of location of spore trap sample obtained at the west end of the Gymnasium.**

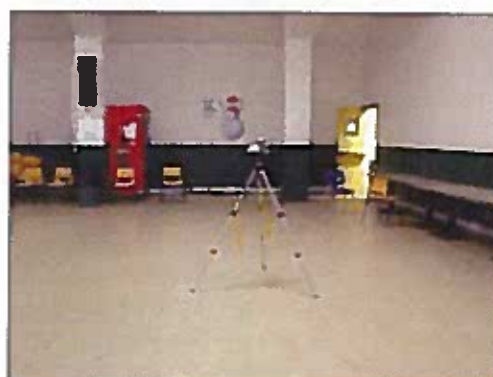
**Photo 6 – View of location of the spore trap sample obtained at the east end of the Gymnasium.**

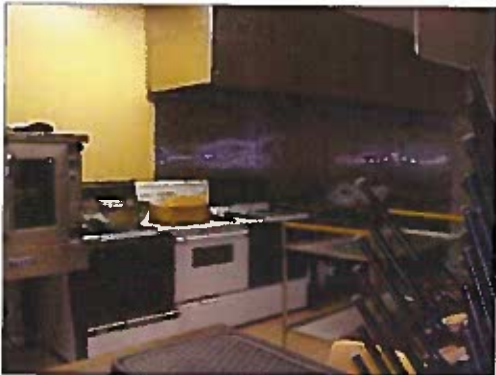
Photo 7 – General view of the Kitchen, facing the north wall.	Photo 8 – View of location of the spore trap sample obtained in the middle of the Kitchen.

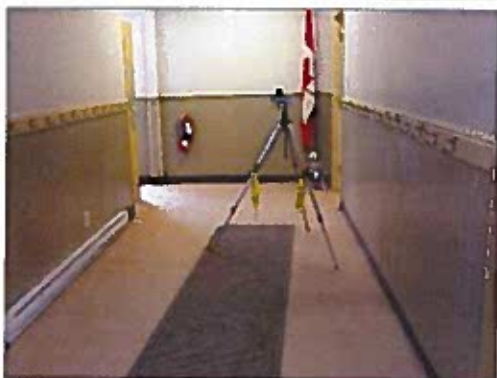
Photo 13 – View of location of spore trap sample obtained in the back section of the Lobby.

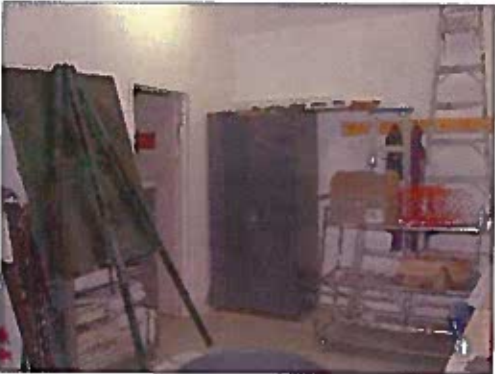
Photo 17 – View of southeast corner of the Classroom, doorway leading to the Electrical Room is on the left.	Photo 18 – View of location of spore trap sample obtained in the Classroom, across from the Electrical Room doorway.

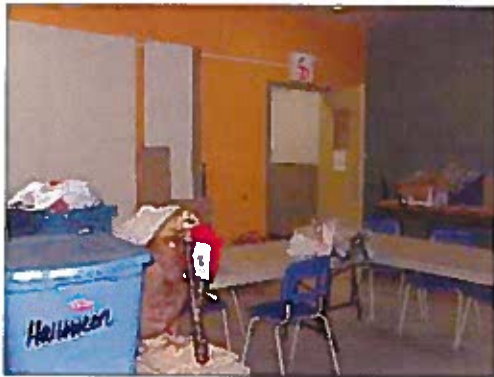
Photo 19 – View of northeast corner of the Classroom, doorway leading to the Lobby is on the right.

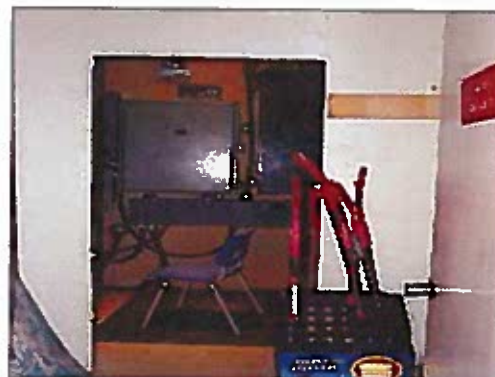
Photo 24 – View of Small Storage Area leading into the Electrical Room from the Classroom.

In the southeast corner of the Classroom there is a doorway leading into a Small Storage Area which then further leads to an Electrical Room, with dimensions of approximately 11 by 9 feet (Photo 24). There are two hot water tanks in the Small Storage Area along the south wall. Exposed insulation was noted around the base of the tanks and minor water stains was noted on the floor (Photo 25). Inside the Electrical Room there is evidence of water damage; this includes staining on the door leading into the Electrical Room (2 ft<sup>2</sup>). There is staining behind the electrical wood panelling all along the east and south walls (10 ft<sup>2</sup>). There is damp insulation around the base of the creosote treated log in the northeast corner and mould growth on the wood joists behind the log along the north wall (2 ft<sup>2</sup>; Photo 26).

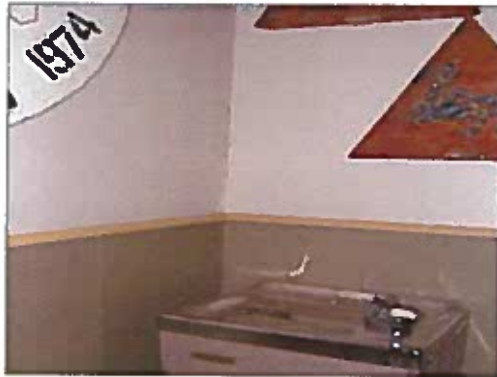
Photo 27 – View of water fountain in southeast corner of the Hallway.

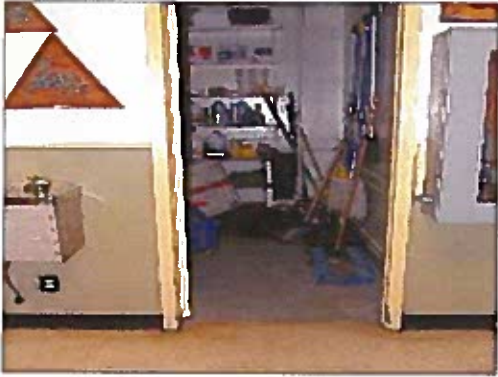
Photo 29 – General view of Janitor's Closet at south end of hallway.	Photo 30 – Location of spore trap sample obtained in the middle of Janitor's Closet.

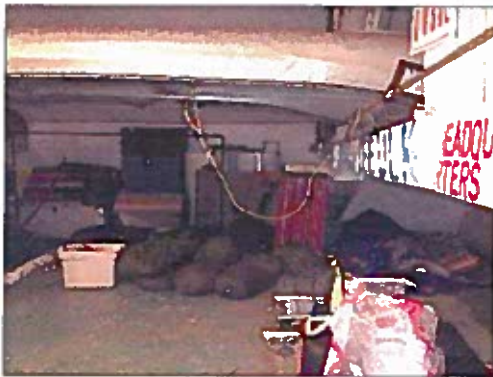
Photo 36 – General view of upstairs equipment room, facing south wall.

The Upstairs Equipment Room dimensions are approximately 29 by 30 feet. The ceiling is composed of plywood which was in poor condition in several areas (Photo 38). The walls are composed of plywood, and were blocked by lots of debris making access to them difficult (Photo 36). The floor is

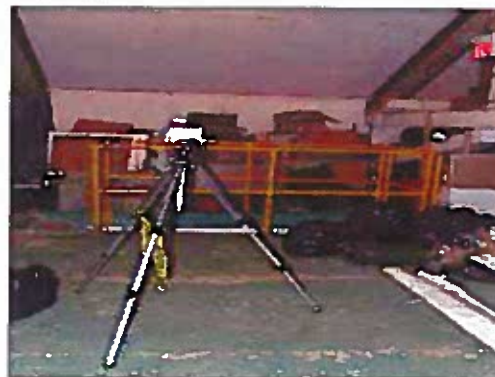
Photo 37 – View of location of spore trap sample obtained in upstairs equipment room, near top of stairs facing the north wall.

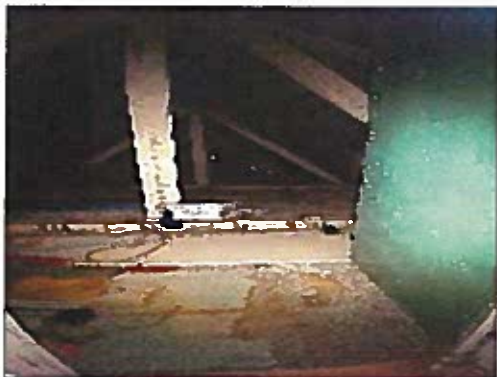
Photo 40 – View inside attic above the Gymnasium.

On the west wall of the Upstairs Equipment Room is a raised doorway leading out to the Attic that is located above the Gymnasium. The floor in the Attic is the backside of the pin-hole fissure ceiling tile in the Gymnasium and is covered in insulation in poor condition (i.e. damp) and other debris (Photo 40). On the north wall of the Upstairs Equipment Room is a small hole that gives restricted access to the Attic area that is above the Kitchen. The floor there is also the backside of the pin-hole flex ceiling tile in the Kitchen and is covered in insulation in poor condition (i.e. damp; Photo 41). The entire upstairs was noted to be very cold.

- n. Conduct further intrusive investigation for mould in the hallway, on the wall common with the Girl's Washroom.
6. Following Type 1 asbestos abatement procedures remove the water-damaged insulation in the Attic. Some of the debris on the floor of the attic contains transite, which contains asbestos.

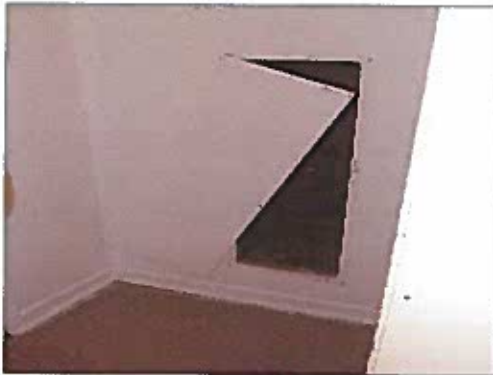
Photo 42 – View of access panel on the north wall inside the Girl's Washroom, to the left of stalls.

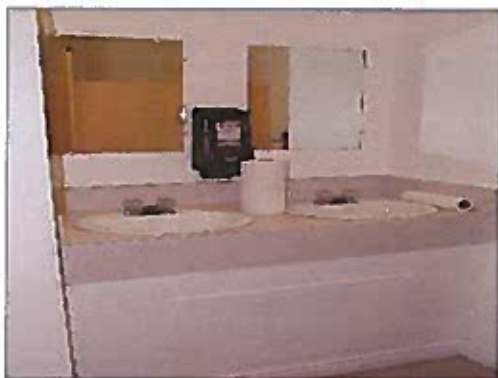
Photo 46 – View of sinks in the Boy's Washroom.

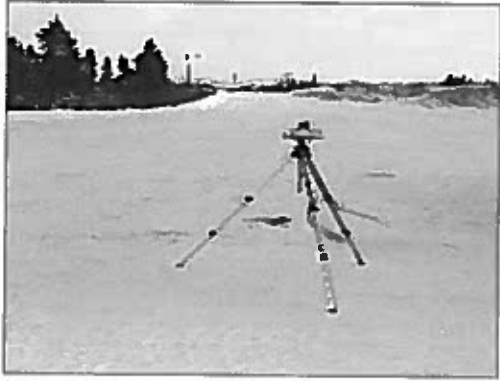
Photo 48 – View of location of spore trap sample obtained in front parking lot.
